Winter Hill Community School 115 Sycamore Street Somerville, MA 02145

AHERA Three-Year Reinspection

PROJECT: AHERA Three-Year Reinspection

DATE: October 2023

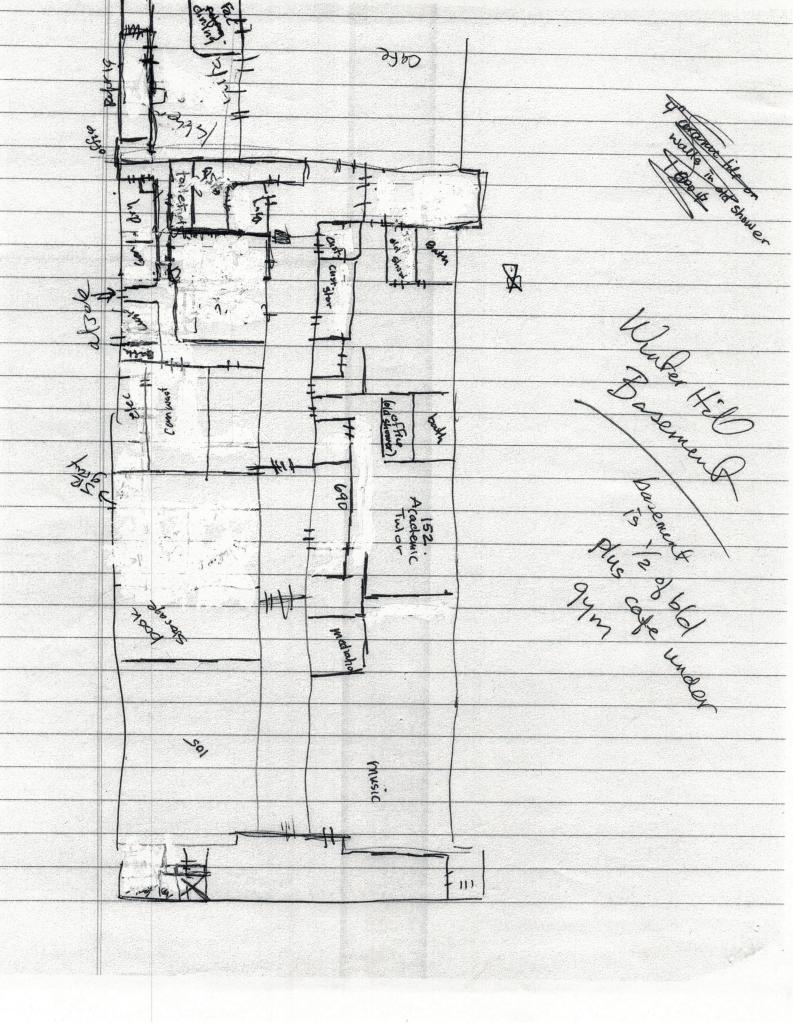
3 4 210 204 224 00 223 Rest Ast. 205 R Health 23 conf. Run 00 Group 206 OFFIG Princ. Record 2nd FL Shoot Books 241 246 1 242 247 work Born 249 244 245 250 Guls Total Services who

The floor plan found in Attachment B should be used to identify functional spaces identification.
